Flight Diesel TB 09/30 R1

SUBJECT: Navistar DT466/570 Tech. Bulletin – Common Issues PG. 1 September 30, 2017

This Technical Bulletin addresses common issues encountered when installing HEUI G2.9 Injectors for the Navistar/International DT466/570 application.

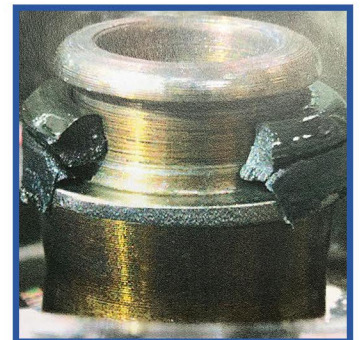
Bad oil rail seal

Installation Information: Injector Inlet Seals **MUST** be replaced on the oil rail/manifold when installing G2.9 Injectors. Oil Rail Seal Kit FD P/N: **FS01804**

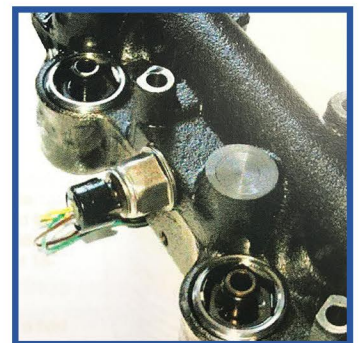
ICP Sensor Location

This issue is commonly a bad ICP Sensor. A vehicle with a bad ICP sensor will start with the sensor unplugged, and will not start with the sensor plugged in. The ICP sensor connector is the second connector from the rear of the valve cover gasket, hidden behind the crankcase vent. Severe high pressure oil leaks could be caused by damaged oil rail seals. These seals **MUST** be replaced every time injectors are removed and re-installed. Oil Rail Seal Kit FD P/N: **FS01804** A torn seal can cause a misfire on one cylinder. Multiple bad seals can cause a No Start or Stalling issue.

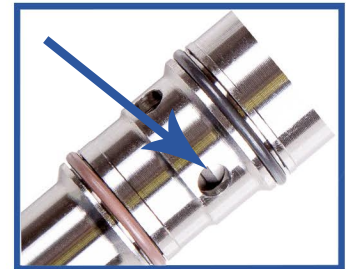
Figure 1

In engines with good compression, this type of failure is commonly caused by insufficient fuel supply pressure or debris entering the injector during the installation process. These injectors are highly susceptible to failure from debris, because there are no filter screens in the fuel inlet of the injector (Figure 1). Warranty analysis commonly reveals dirt and/or metal debris in the fuel side or oil side of the injector (Figure 2). Contamination from metal debris is common in cases where injectors were installed during an engine overhaul. Incorrect maintenance intervals/procedures of the fuel and oil systems can also allow debris to enter the injector and cause failures. Coil wires can be pinched during installation, also causing misfires (Figure 3).

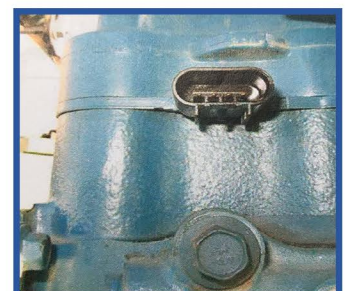
Figure 4

Injector harness failures are common in early applications. The valve cover gasket has integrated circuits for injectors and ICP sensor, and failures from “Oil Wicking” are common (Figure 4). Injector circuit codes and misfires under load are commonly caused by poor connections at the valve cover gasket. Use the latest design with improved electrical locks to avoid this issue. The harness connector in the early applications does not have a secondary lock, allowing it to lose continuity when the engine is torqued up in the chassis. Double check all connectors are secured. There is a TSI letter on an updated lock used on the later engines. TSI Number: 05-12-10 TSI Date: February 2005.
